Working Together to
Restore and Protect
Our Natural
Resources

KURTZ ROAD CROSSING IMPROVEMENT
Reprinted with the permission of Huron Pines

Crossing Quadrupled to Improve Fish Passage

Summer 2021 Newsletter

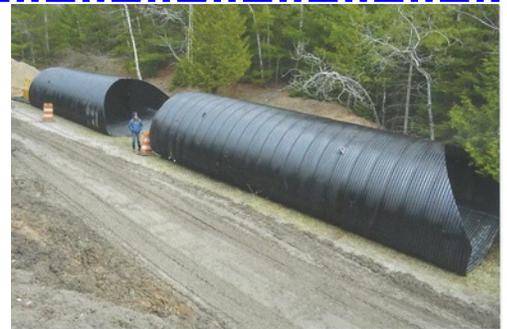
For a sense of scale, Watershed Planner Amy Nowakowski stands next to the new structure designed to replace the undersized culvert at Kurtz Creek.

The new structure, installed at the end of April, is 14 feet wide and 9 feet high, more than 4 times wider than the original culvert. The increased size allows Kurtz Creek to flow naturally through the crossing, virtually eliminating any risk of a future washout from sudden spring thaws or rainstorms. The improved design allows fish to reach 5.8 miles of quality cold-water habitat upstream from Kimberlin Road.

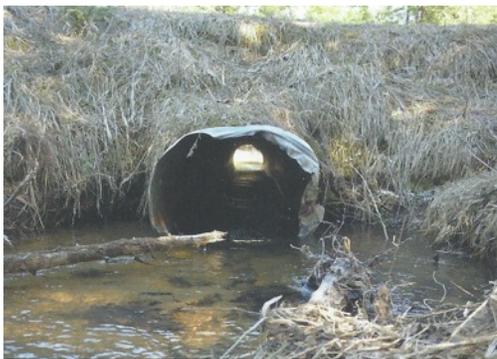
A before photo of the original, 3-foot-diameter culvert.

Our first river restoration project of 2021 replaced a severely undersized culvert on Kurtz Creek, a tributary of the South Branch Pine River. The culvert replacement occurred where Kurtz Creek intersects with Kimberlin Road east of Glennie in Alcona County. Until it was removed, the old culvert was perched above the river surface, causing issues with erosion and preventing fish and other river life from being able to move upstream.

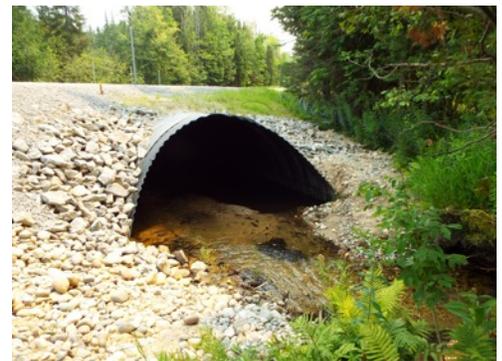
After view of the upstream end.

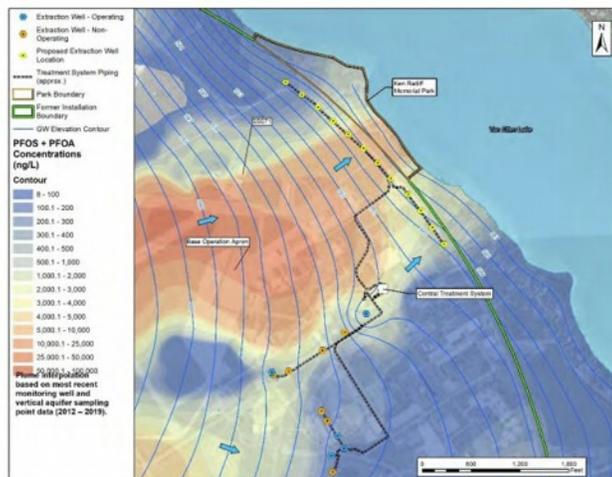
Figure 2: PFOS Concentrations in Groundwater at Ken Ratliff Memorial Park and Proposed Location of Hydraulic Control System for Alternatives 2 and 3

this migration is alternative 3, hydraulic control, using pump and treat with granular activated carbon (GAC). The IRA will include a line of extraction wells that will intercept flow with the highest concentrations of PFAS.

The extraction wells will remove approximately 724,320 gallons of groundwater per day. Extracted groundwater will be treated and then discharged to the

storm drain using the existing treatment system infrastructure at the Central Treatment System (CTS). The CTS's treatment capacity will be doubled to handle the increased load. The IRA will also provide information to support the ongoing site-wide remedial investigation (RI) and future feasibility study (FS).
